Quad City Home Inspection  
12123 Turkey Hollow Road  
Taylor Ridge, IL 61284  
Richard A. VanOteghem CPI  
Illinois License No. 450.011466

My Street  
Anywhere, IL

# Quad City Home Inspection

15:05 November 06, 2019

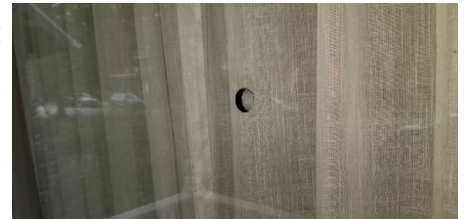
1. Windows: Wood double hung, Wood picture - Picture window has been shot with a BB gun. The windows in this home are varying condition. Some are okay, some won't open, some won't stay open, all leak cold air and all need refinishing. They are the original windows.

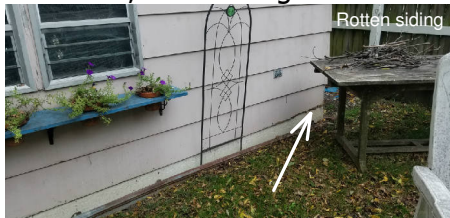
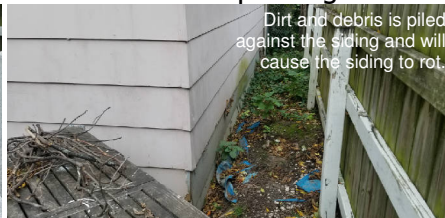
2. Detached, Rear Garage Garage Man Door Wood - Knob lock does not work. Deadbolt works.
3. Detached, Rear Garage Door Operation: Mechanized - When trying to close the door, it would stop. it took several tries. I believe the tension adjustment on the opener needs to be adjusted and/or the door track needs lubrication.
4. Detached, Rear Garage Exterior Surface: Masonite lap siding - Bottom edges of some of the siding is rotted.

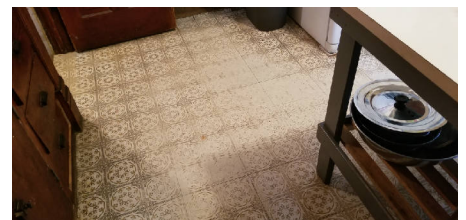
5. 1st Floor Kitchen Cabinet Drawer Slides: Sticky, dont close tight
6. 1st Floor Kitchen Floor: Floor tile - Worn

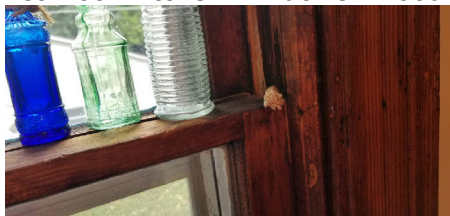
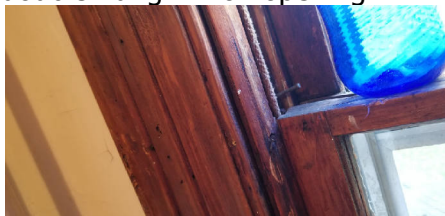
7. 1st Floor Kitchen Windows: Wood double hung - Non opening

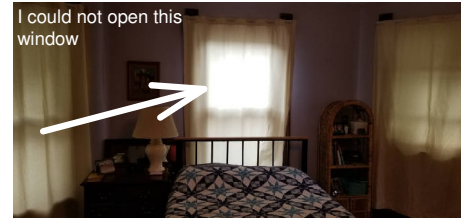
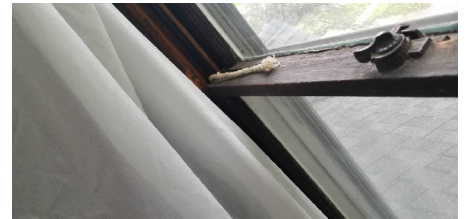
8. 2nd Floor Master Bedroom Windows: Wood double hung - One wouldn't open
9. Front Bedroom Windows: Wood double hung - Counter weights missing or broken rods

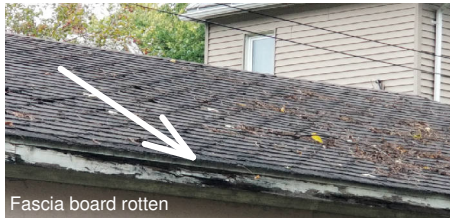
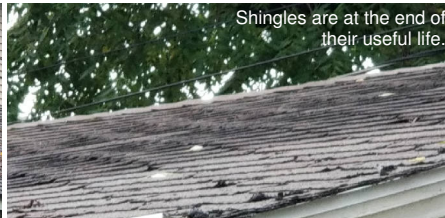
1. Detached, Rear Garage Roof: Asphalt shingle - Shingles are curled and are at the end of their useful life. Fascia board is also rotten

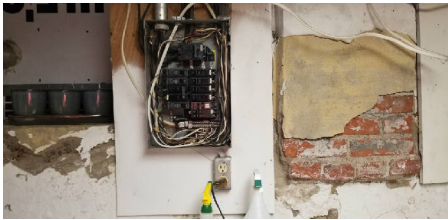
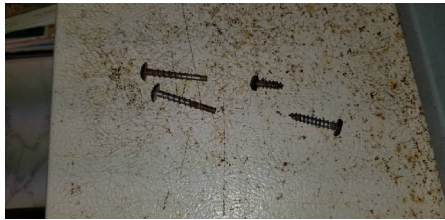
3. Basement Electric Panel Manufacturer: General Electric - Two cover screws are sharp

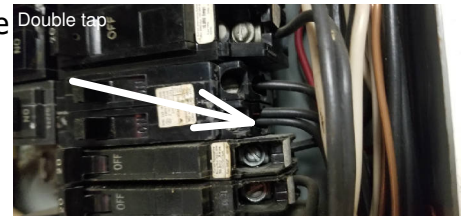
4. Basement Electric Panel Double Tapping Two circuits on one breaker - There is one double tap in this panel and these breakers are not designed to accommodate two wires.

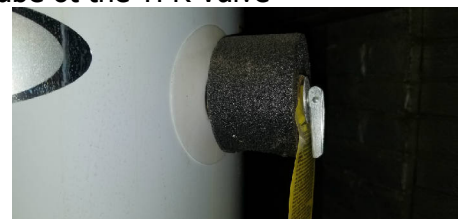
5. Gas Valve(s): Mixture of antique and modern ball valves - Antique valves will eventually develop leaks. In fact the valve on the water heater has a miniscule gas leak. I notified the seller and she contacted a plumber to repair this, replace the flexible gas line on the water heater and add a drop tube of the TPR Valve
6. Basement Water Heater TPRV and Drain Tube: Copper - No drop tube

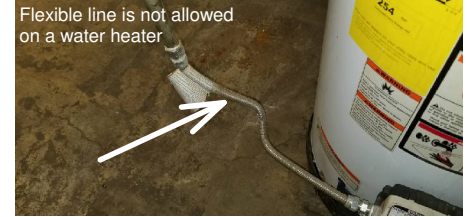
7. Basement Water Heater Flexible Gas Lines: The water heater gas line should be rigid piping - Flexible gas lines are not allowed on water heaters. Water heater needs to have rigid piping and a new gas valve.

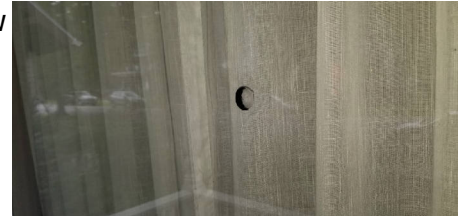
6. ☒ ☐ ☐ ☐ ☐ Entry Doors: Wood  
7. ☒ ☒ ☐ ☐ ☐ Patio Door:  
8. ☐ ☐ ☐ ☒ ☐ Windows: Wood double hung, Wood picture - Picture window has been shot with a BB gun. The windows in this home are varying condition. Some are okay, some won't open, some won't stay open, all leak cold air and all need refinishing. They are the original windows.

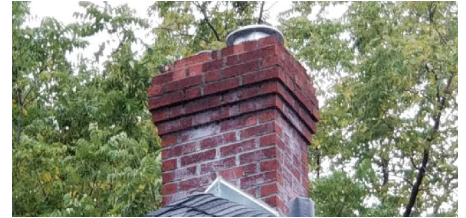
8. ☒ ☐ ☐ ☐ ☐ Electrical Mast: Surface mount  
9. Drip Edge ☒ Yes ☐ No Aluminum  
10. ☒ ☐ ☐ ☐ ☐ Gutters: Aluminum  
11. ☒ ☐ ☐ ☐ ☐ Downspouts: Aluminum  
Center of home Chimney \_\_\_\_\_  
12. ☒ ☐ ☐ ☐ ☐ Chimney: Brick - Some efflorescence

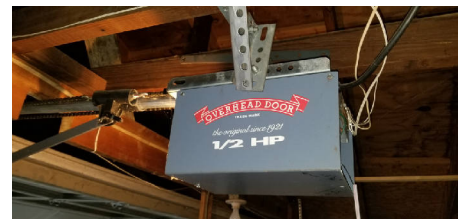
1. Type of Structure: Detached Car Spaces: 2  
2. ☐ ☐ ☐ ☒ ☐ Garage Man Door Wood - Knob lock does not work. Deadbolt works.  
3. ☒ ☐ ☐ ☐ ☐ Garage Doors: Metal  
4. ☐ ☐ ☐ ☒ ☐ Door Operation: Mechanized - When trying to close the door, it would stop. it took several tries. I believe the tension adjustment on the opener needs to be adjusted and/or the door track needs lubrication.  
5. ☒ ☐ ☐ ☐ ☐ Door Opener: Overhead Door - Beam

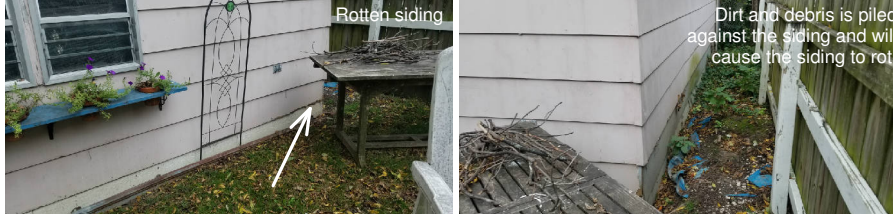
7. ☐☐☐☒☐ Exterior Surface: Masonite lap siding - Bottom edges of some of the siding is rotted.

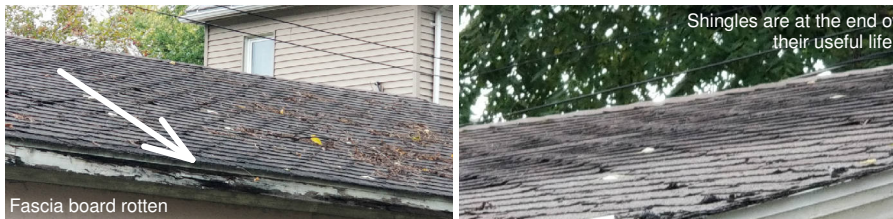
8. ☐☐☐☐☒ Roof: Asphalt shingle - Shingles are curled and are at the end of their useful life. Fascia board is also rotten

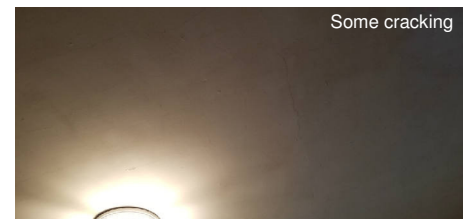
17. ☒☐☐☐☐ Ceiling: Plaster - Some cracking

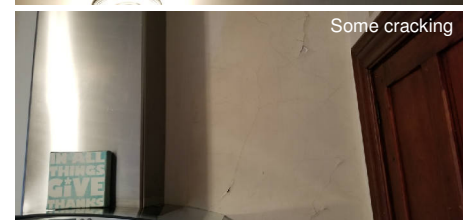
18. ☒☐☐☐☐ Walls: Plaster - Some cracking

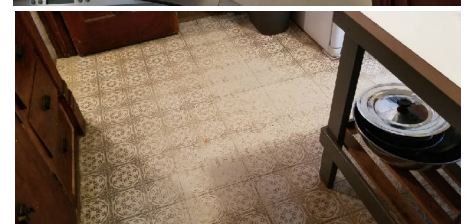
19. ☐☐☐☒☐ Floor: Floor tile - Worn

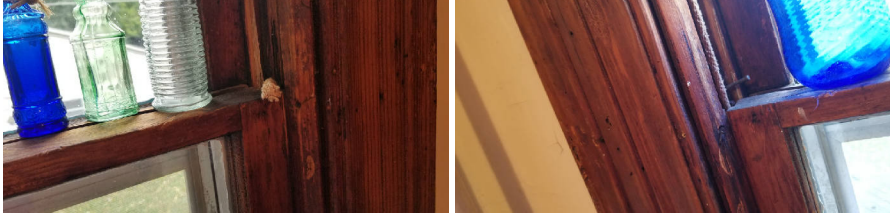
21. ☐☐☐☒☐ Windows: Wood double hung - Non opening

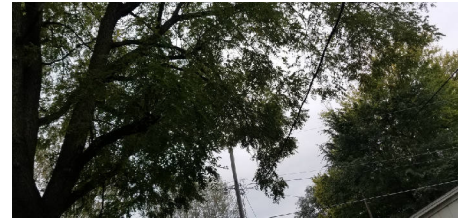
2. ☒☐☐☐☐ Vegetation Around Cable Tree branches may be a problem in the future as the tree grows

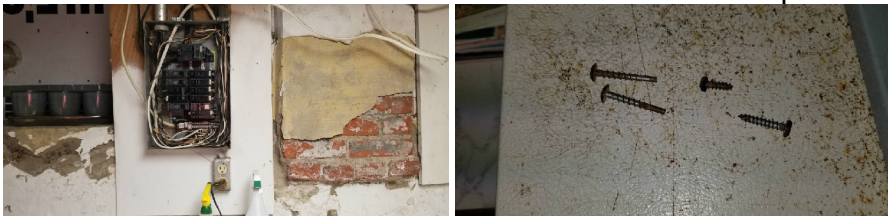
12. ☐☐☐☐☒ Manufacturer: General Electric - Two cover screws are sharp

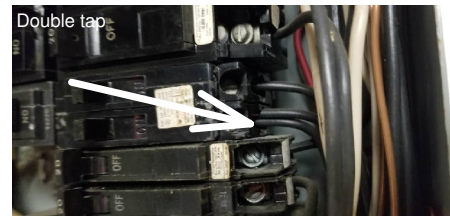
15. ☒ ☐ ☐ ☐ ☐ Breakers: Copper and Aluminum  
16. ☐ ☐ ☐ ☐ ☒ Double Tapping Two circuits on one breaker - There is one double tap in this panel and these breakers are not designed to accommodate two wires.

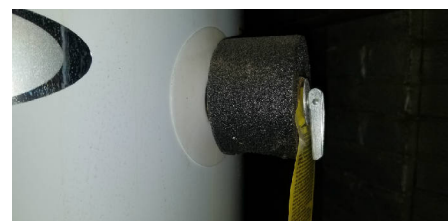
11. Model Number: N40S61-403 Serial Number: 1207T456821
12. Type: Natural gas Capacity: 40 Gal.
13. Approximate Age: 12 years (the average life expectancy of a water heater is 7-12 years) Area Served: Entire home
14. ☒ ☐ ☐ ☐ ☐ Flue Pipe: Single wall
15. ☐ ☐ ☐ ☐ ☒ TPRV and Drain Tube: Copper - No drop tube

3. ☒ ☐ ☐ ☐ ☐ Water Lines: Copper
4. ☒ ☐ ☐ ☐ ☐ Drain Pipes: PVC, Cast iron, Copper
5. ☒ ☐ ☐ ☐ ☐ Service Caps: Accessible
6. ☒ ☐ ☐ ☐ ☐ Vent Pipes: Cast iron, Copper
7. ☒ ☐ ☐ ☐ ☐ Gas Service Lines: Cast iron
8. ☐ ☐ ☐ ☐ ☒ Gas Valve(s): Mixture of antique and modern ball valves - Antique valves will eventually develop leaks. In fact the valve on the water heater has a miniscule gas leak. I notified the seller and she contacted a plumber to repair this, replace the flexible gas line on the water heater and add a drop tube of the TPR Valve

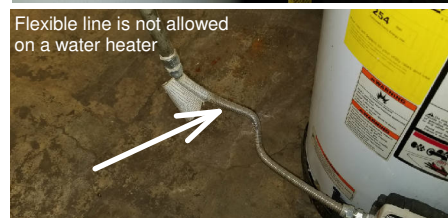
16. ☐ ☐ ☐ ☐ ☒ Flexible Gas Lines: The water heater gas line should be rigid piping - Flexible gas lines are not allowed on water heaters. Water heater needs to have rigid piping and a new gas valve.

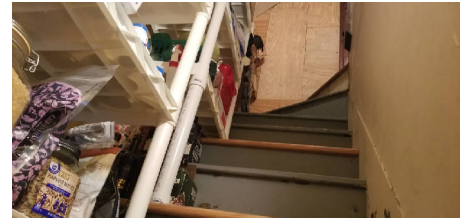
- ☒☐☐☐☒ Rise & Run Main staircase is to code, basement stairs, back stairs and attic stairs are very steep - It would be impossible to change the rise and run on these staircases but railing will make them safer.
- Railing Continuous ☐ Yes ☒ No No railing on back stairs, attic stairs or basement stairs
- Spindle Spacing Correct? ☒ Yes ☐ No Porch spindles are spaced properly

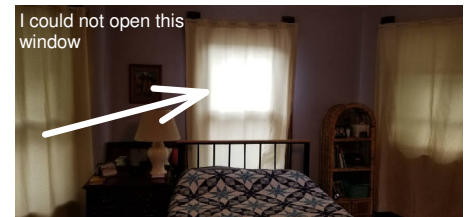
15. ☐☐☐☒☐ Windows: Wood double hung - One wouldn't open

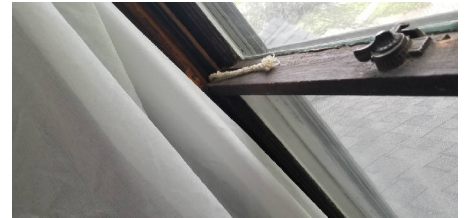
20. ☒ ☐ ☐ ☐ ☐ Ceiling: Paint  
21. ☒ ☐ ☐ ☐ ☐ Walls: Drywall  
22. ☒ ☐ ☐ ☐ ☐ Floor: Hardwood  
23. ☒ ☐ ☐ ☐ ☐ Doors: Solid wood  
24. ☐ ☐ ☐ ☒ ☐ Windows: Wood double hung - Counter weights missing or broken ro0es
