Quad City Home Inspection  
12123 Turkey Hollow Road  
Taylor Ridge, IL 61284  
Richard A. VanOteghem CPI  
Illinois License No. 450.011466

My Street  
Anywhere, IL

# Quad City Home Inspection

15:05 November 06, 2019

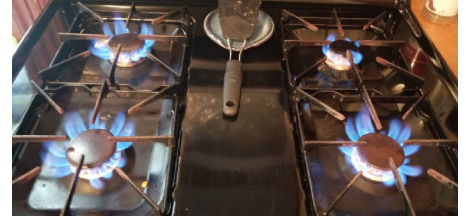
2. ☐☐☐☐☒ Anti-tip device Prevents stove from tipping forward spilling stove top contents on the user or climbing child. Anti-tip device has not been installed this is a dangerous condition.

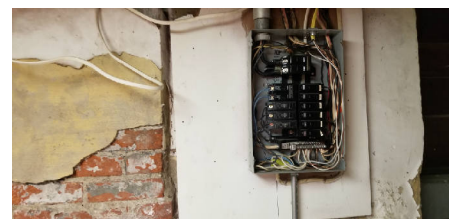
Basement Electric Panel

22. ☒ ☐ ☐ ☐ ☐ Manufacturer: General Electric - There are no double taps in this panel

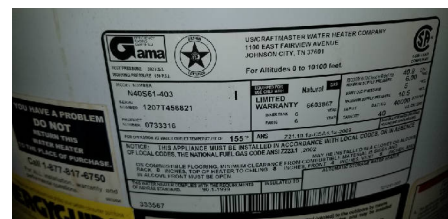
### Basement Water Heater

11. Model Number: N40S61-403 Serial Number: 1207T456821
12. Type: Natural gas Capacity: 40 Gal.
13. Approximate Age: 12 years (the average life expectancy of a water heater is 7-12 years) Area Served: Entire home
14. ☒ ☐ ☐ ☐ ☐ Flue Pipe: Single wall
15. ☐ ☐ ☐ ☐ ☒ TPRV and Drain Tube: Copper - No drop tube

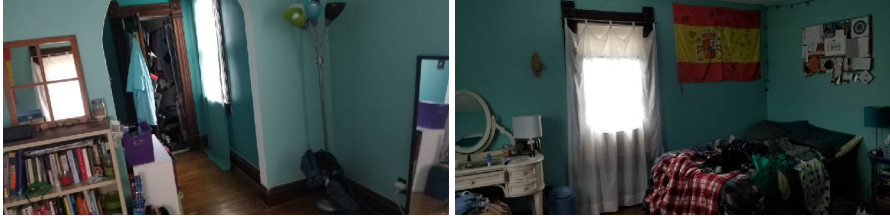
20. ☒ ☐ ☐ ☐ ☐ Ceiling: Paint  
21. ☒ ☐ ☐ ☐ ☐ Walls: Drywall  
22. ☒ ☐ ☐ ☐ ☐ Floor: Hardwood  
23. ☒ ☐ ☐ ☐ ☐ Doors: Solid wood  
24. ☐ ☐ ☐ ☒ ☐ Windows: Wood double hung - Counter weights missing or broken ro0es
